## RAPID ANALYSIS REPORT

# Scientific Anatomy of the 26 August 2026 Bhotekoshi Flash Flood

IRDR Young Scientist's rapid analysis of the flood event

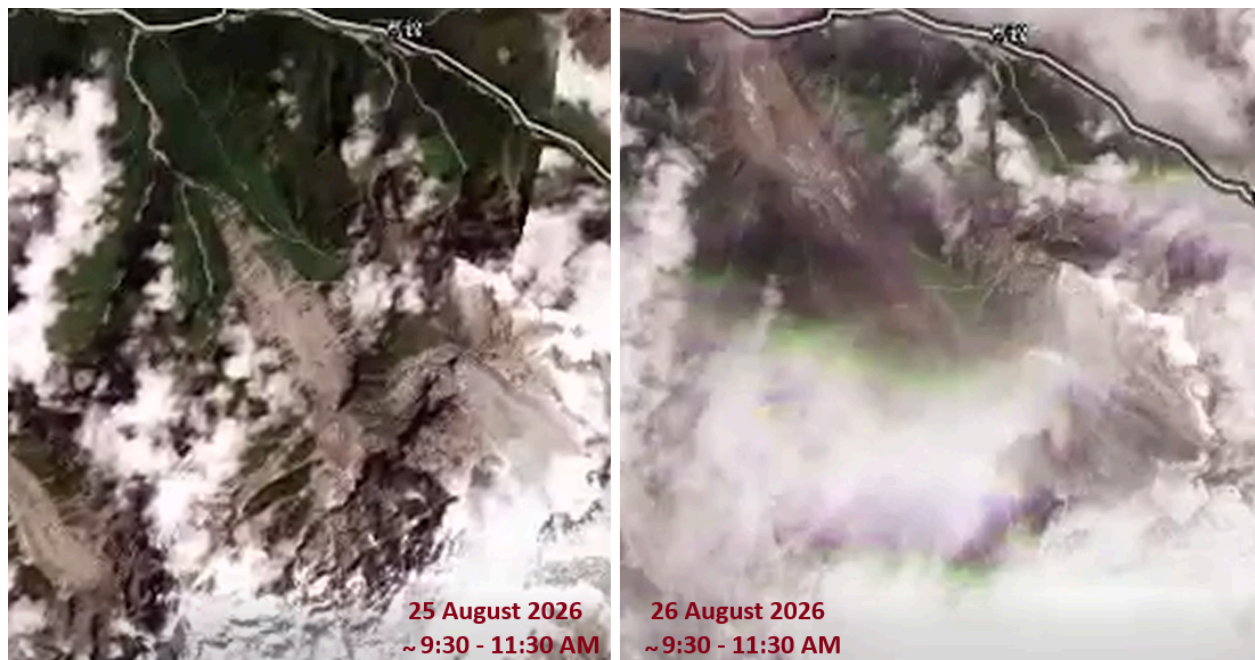
*Image: Satellite image of the ice/rock avalanche location from 25 and 26 August 2026 (Source: Planet).*

Within a few hours, the team examined satellite observations, weather information, rainfall records, and river-discharge data to identify the likely source and mechanism of the event. The initial analysis identified a suspected slope-failure area around Deding in the north face of the Langtang-Lirung region.

Pre-event satellite observations also revealed changes in snow and ice conditions around the suspected source area, including snow retreat and changes in snow accumulation. Subsequent pre-event and post-event satellite imagery showed that the suspected location closely corresponded with the observed source area, strengthening the initial interpretation.

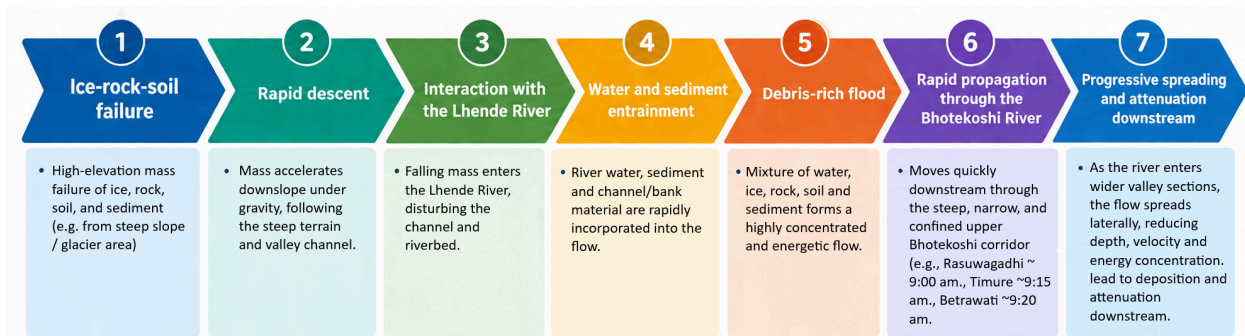
The downstream propagation can therefore be understood as part of a cascading process initiated by the high-elevation ice-rock-soil failure:

The observed arrival times and changing flood behaviour along the river indicate that the magnitude and destructive capacity of the event were controlled not only by the initial volume of water, but also by the mass of ice, rock, soil, and sediment introduced into the river and subsequently entrained during downstream propagation.
